5.2 - Flat

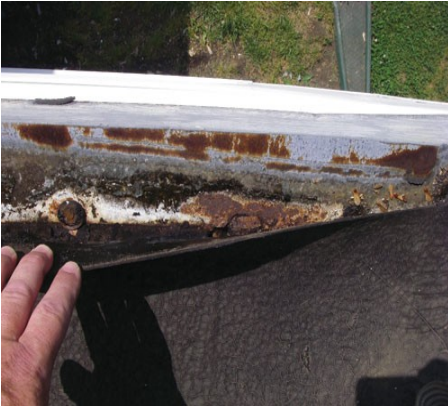
Location	Condition	Picture	Repair	Priority
<p>Front Entrance Porch</p>	<p>The entrance porch has an asphalt roof finish. The overall covering is sound, but the up-stand connection with the main building facade & roof edging is pulling away & is holed.</p>

<p>Cut away the up-stand flashing & renew it in new asphalt. Work required to rectify is minor in application & cost, but is high in priority as damp will penetrate the roof timbers & wall junction between the porch & main building. This could result in more costly future damage.</p>	<p>3</p>
